A380 – QFA – MSN 014

ENGINE #2 FAILURE INCIDENT – OVERVIEW OF MAJOR DAMAGES

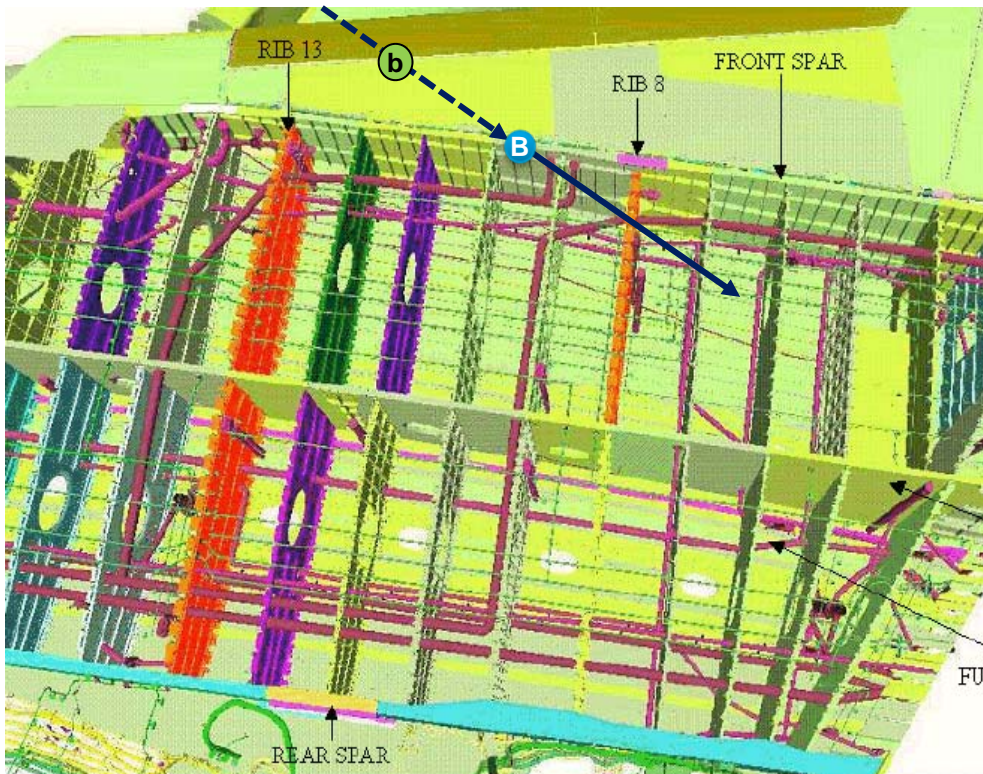
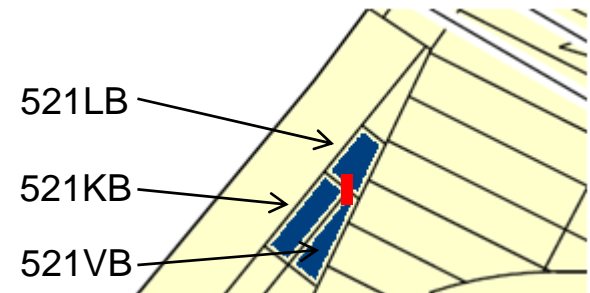
Damage b-B

- Damage description: foreign object crossed the droop nose #2 from junction of panels 521KB-521VB-521LB (bottom skin) to leading edge inboard top panel (P/N L57452496000) upper skin

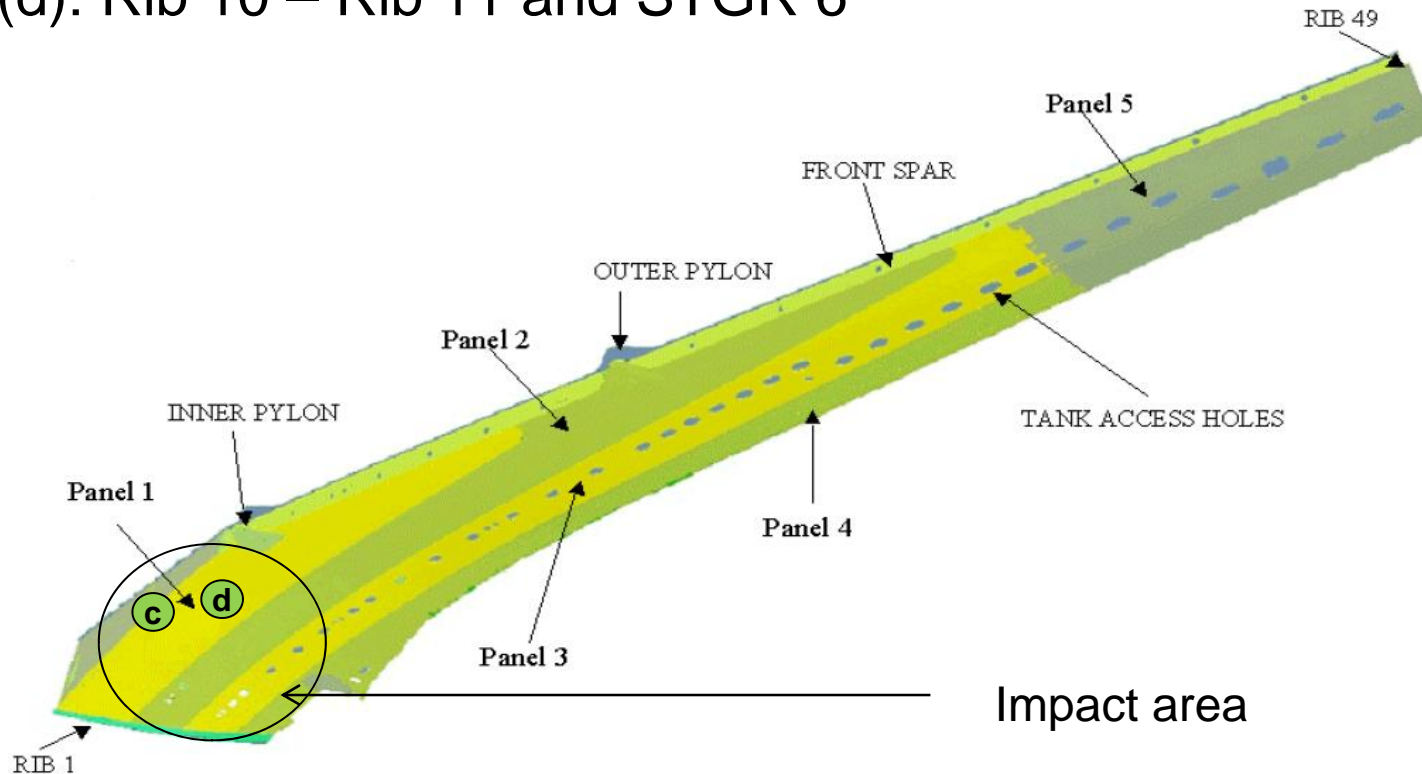
Bottom Skin panel – Major damages

- Inner tank has 2 perforations on panel 1: damages (c) and (d)
- Positions:
 - ▶ (c): Rib 7 and STGR 0
 - ▶ (d): Rib 10 – Rib 11 and STGR 6

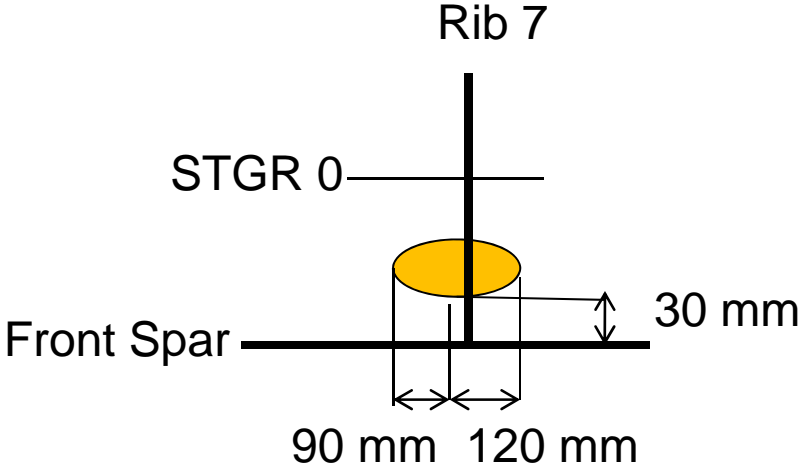
- (c): Rib 7 and STGR 0

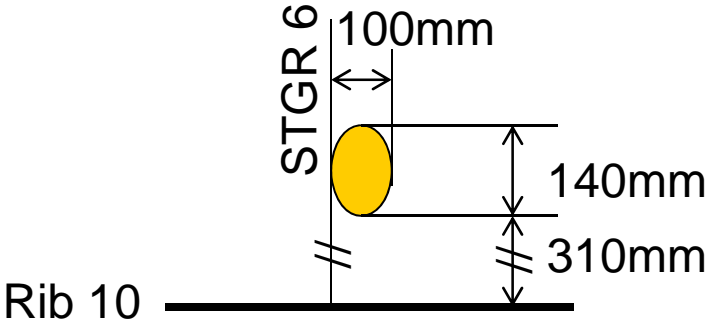
- (d): Rib 10 – Rib 11 and STGR 6

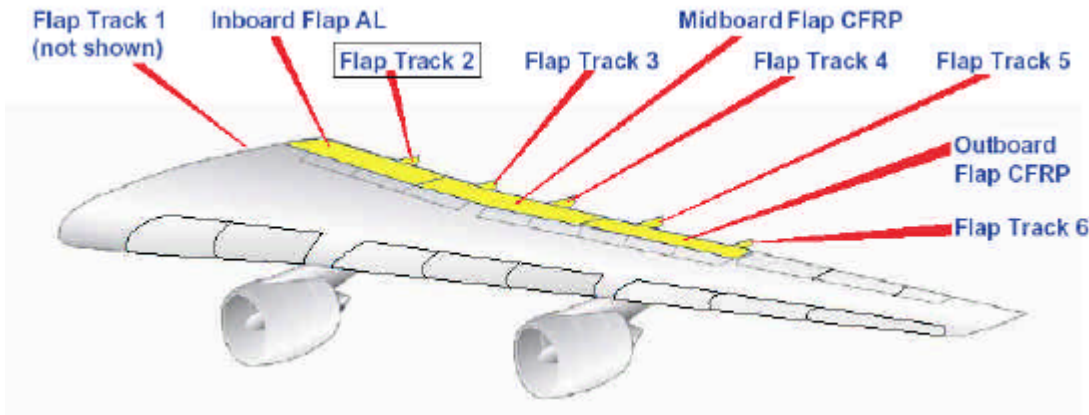
Flap Track Fairings (FTF 2 & 3)

- ▶ Damage (1): foreign object damaged the fixed FTF
- ▶ Damage (2): Movable FTF small impact

- ▶ Damage (3): small impact on fixed fairing

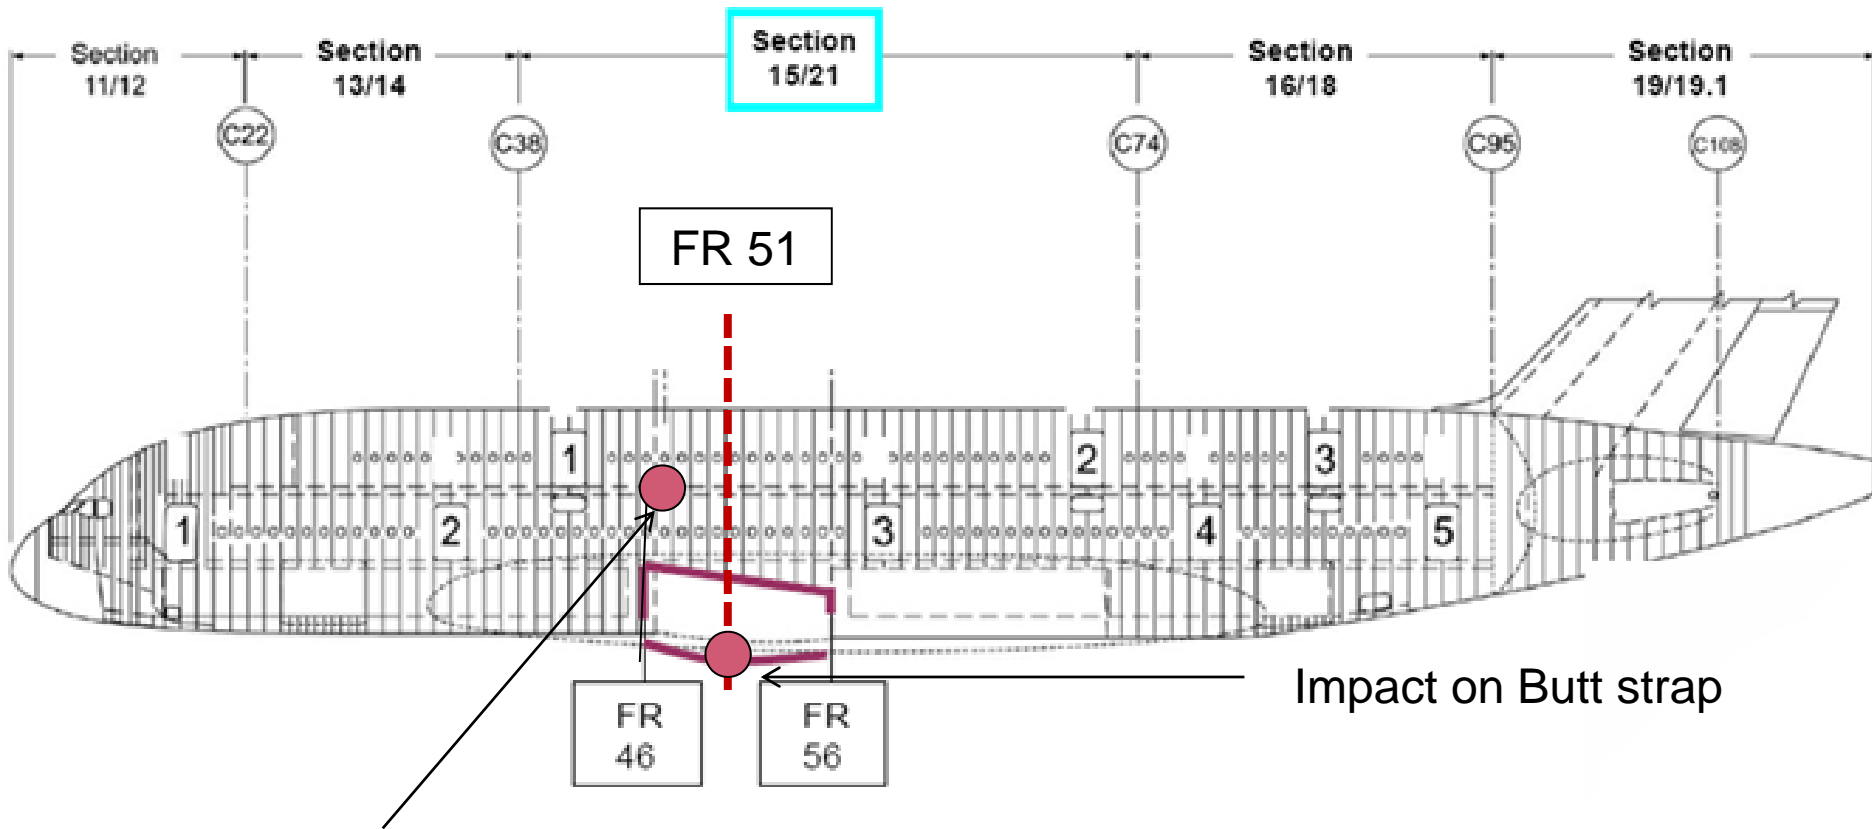
Fuselage / Belly fairing – Major damages

Impact at
FR46/47 and STGR27LH

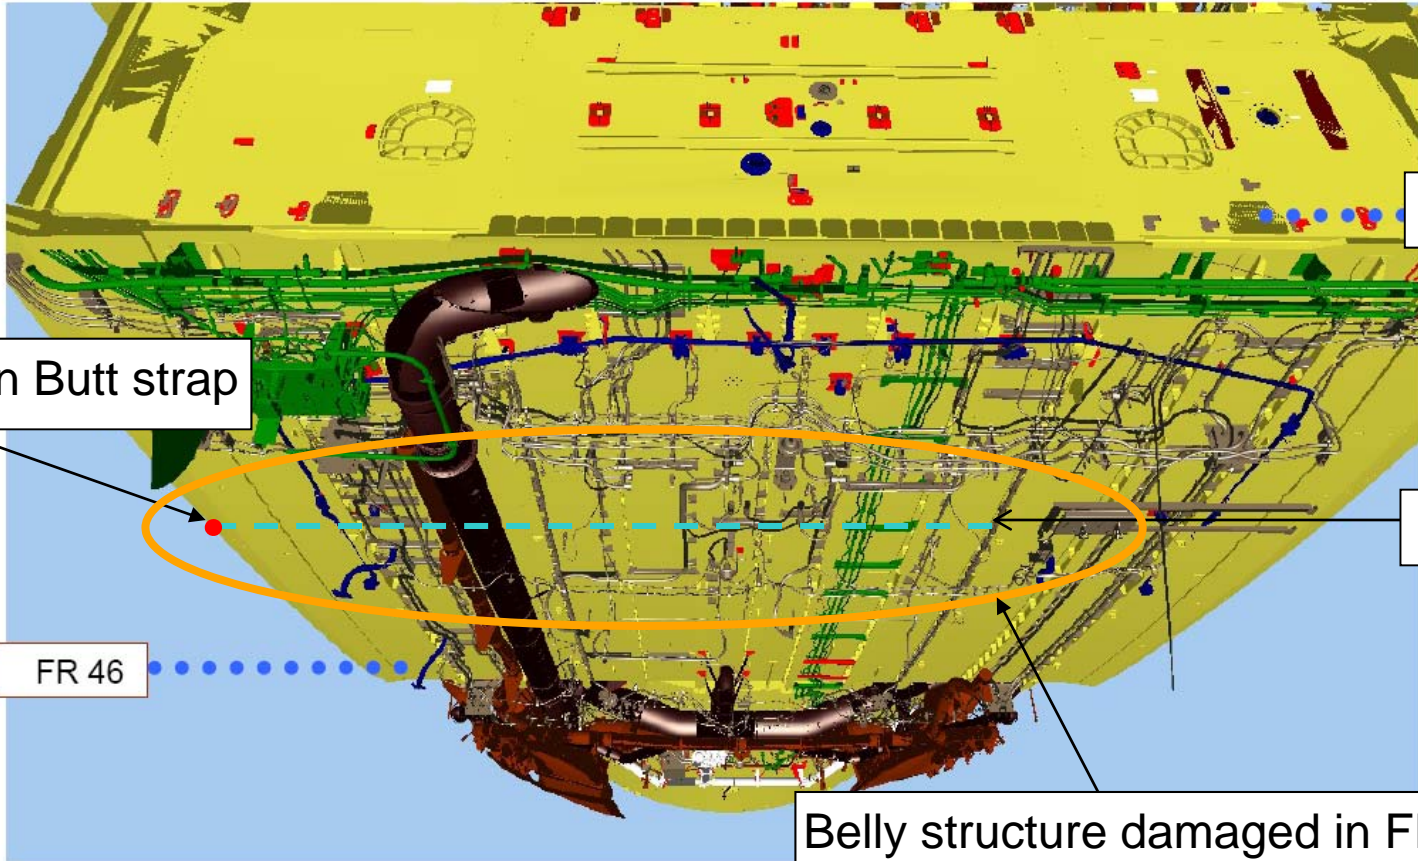
Belly Fairing area

Impact on Butt strap

Belly structure damaged in FR51 area

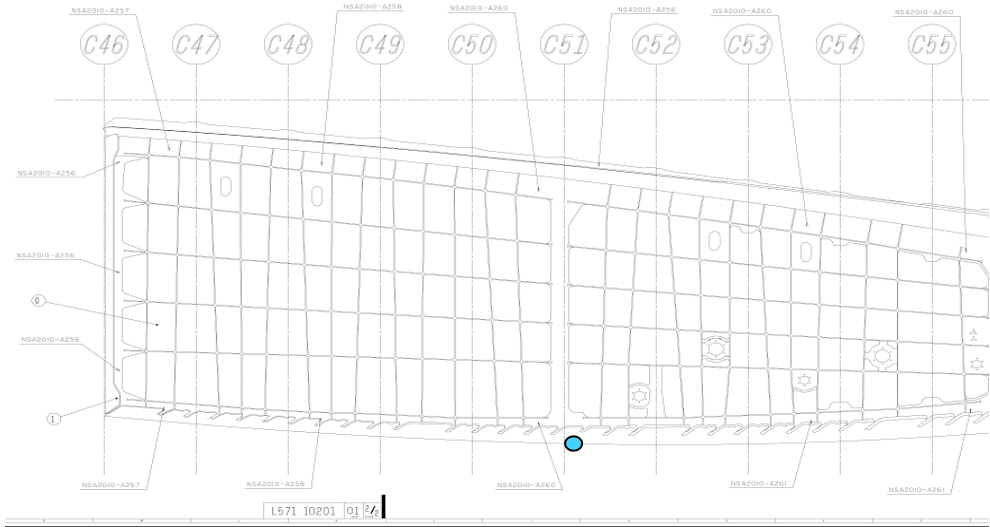
Buttstrap damaged at FR51

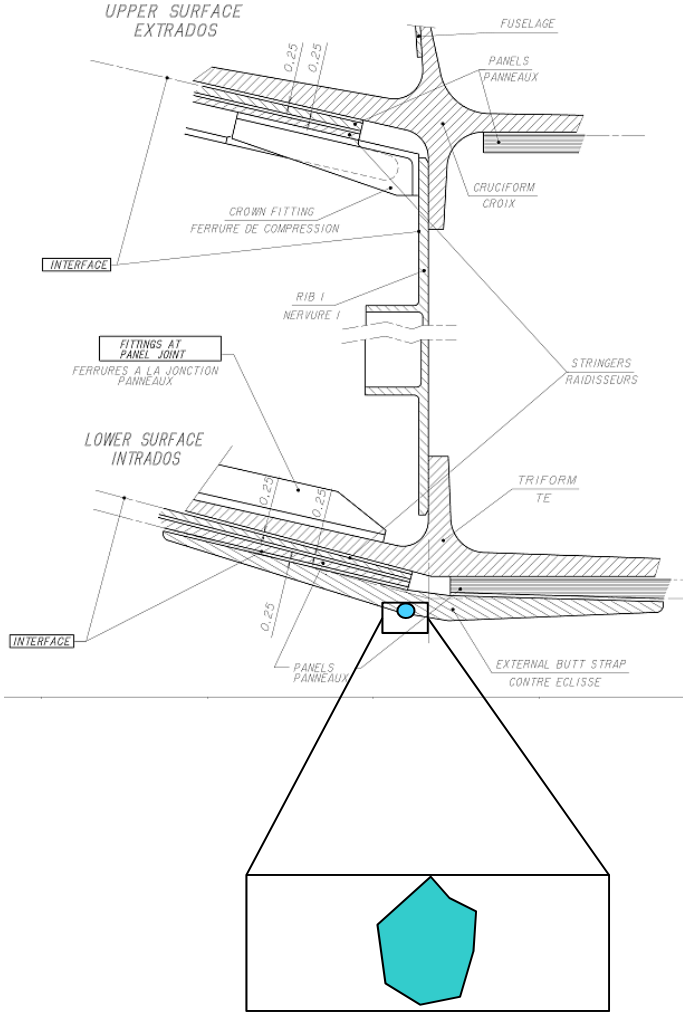
Damage location: FR 51
 Depth: 11 mm
 Dimensions not yet measured
