**Damage ID:** WU-1

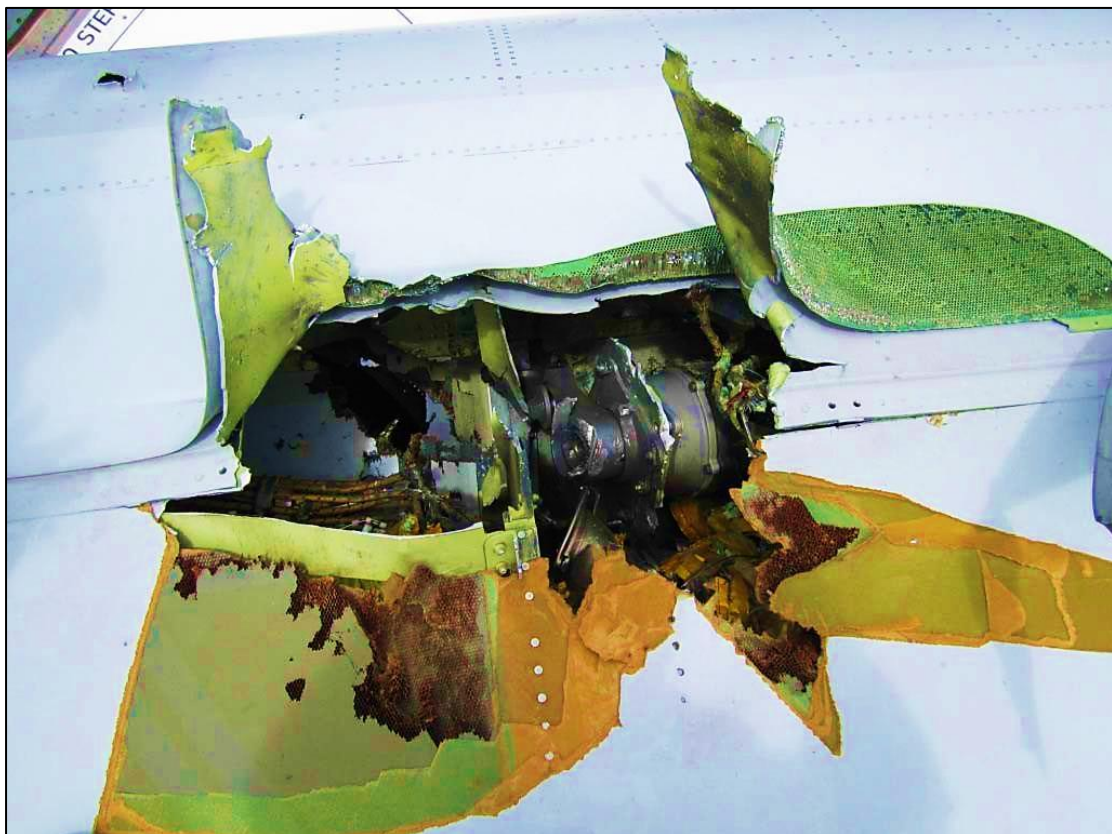
Damage is a single large penetration both the droop nose No. 2 and the wing topskin fixed topskin panels and D nose structure, which were simultaneously damaged after debris travelled through the lower bottom skin and exited at this point on the topskin. Damage to the internal structure at this location includes the drive rib 4 which is part of the leading edge structure (both inboard and outboard locations). Damage to the D nose at this location cannot be clearly defined as yet.

**Figure 1: WU-1 Perforation at topskin Rib 12 location**

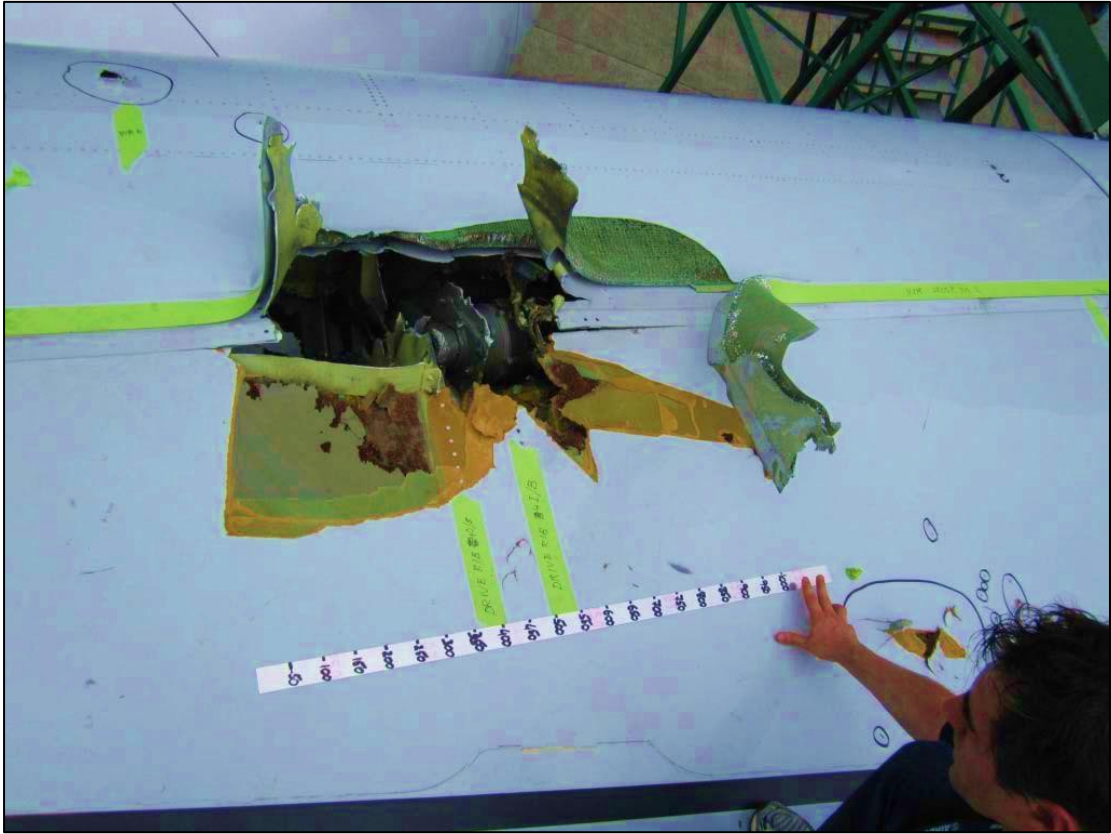
Figure 2: WU-Overall view showing damage to droop nose and D nose (hidden)

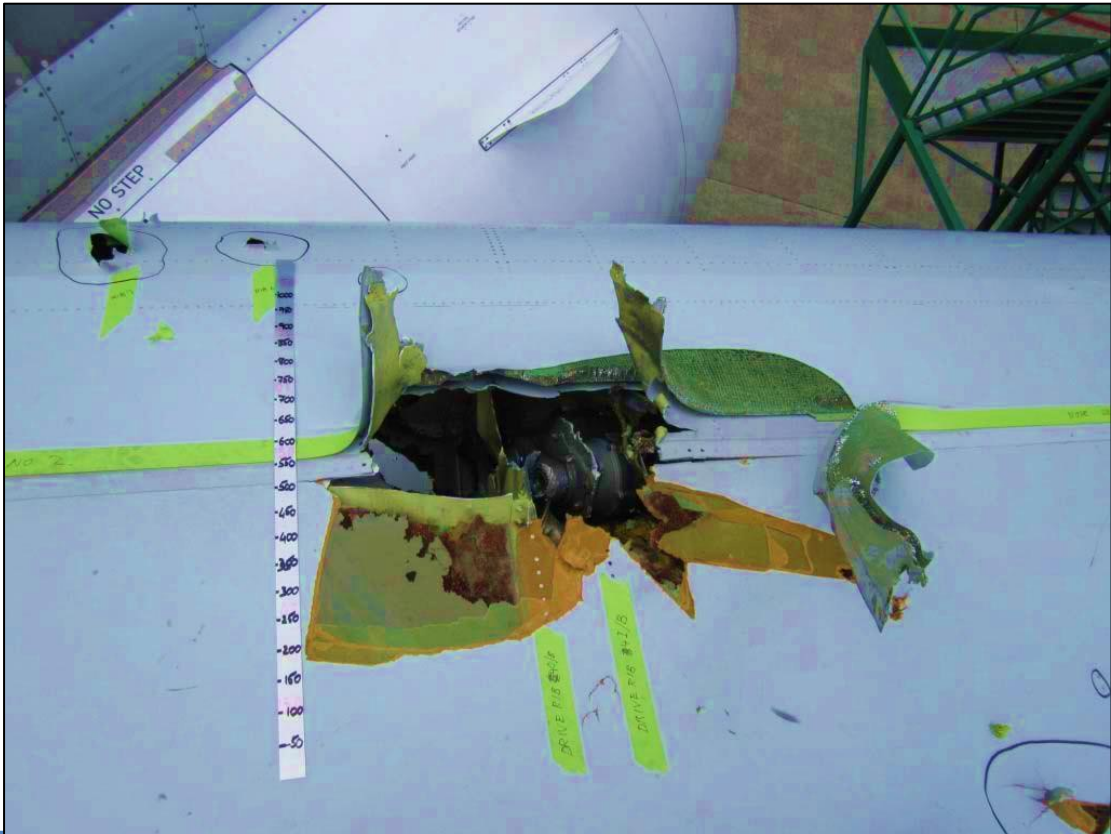
Figure 3: view showing location of damage relative to engine No. 2

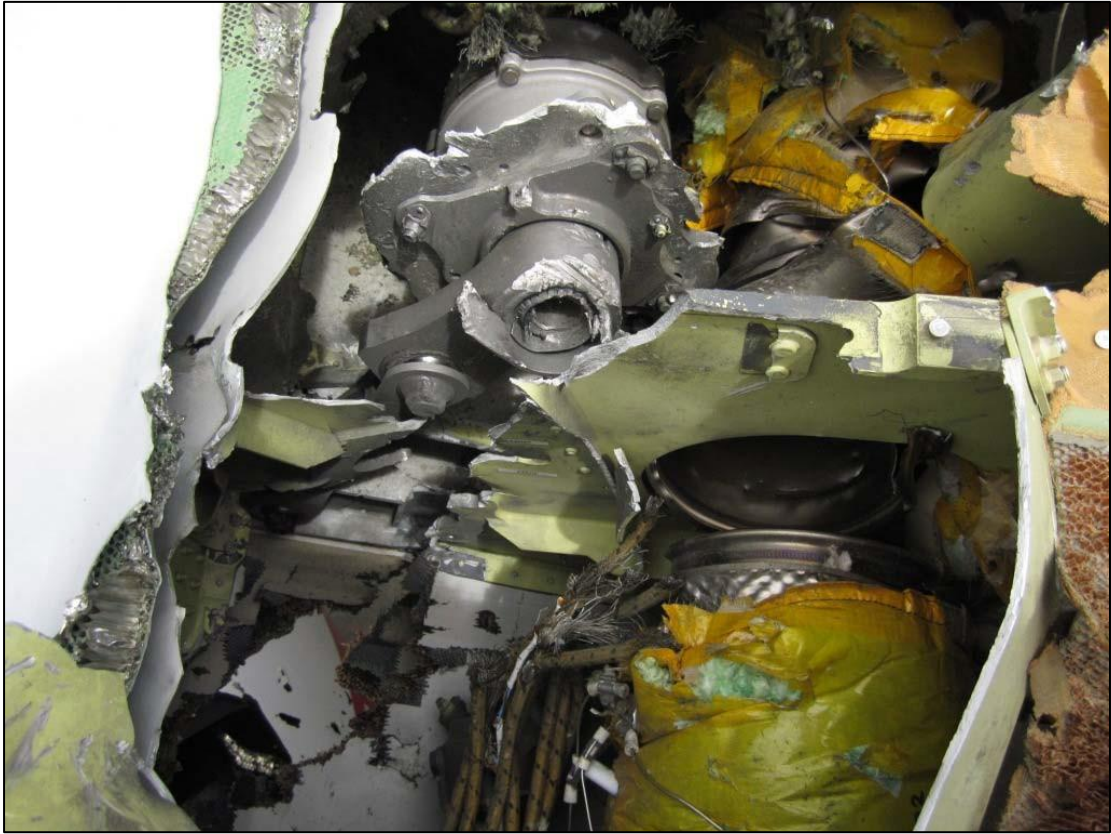
The drive motor for the droop nose located between the inboard and outboard rib 4 of the leading edge has been badly damaged upon impact and seems to have been on the direct path of trajectory through the wing.

Figure 4; Close up of damage between at leading edge ribs 4 showing droop nose drive motor

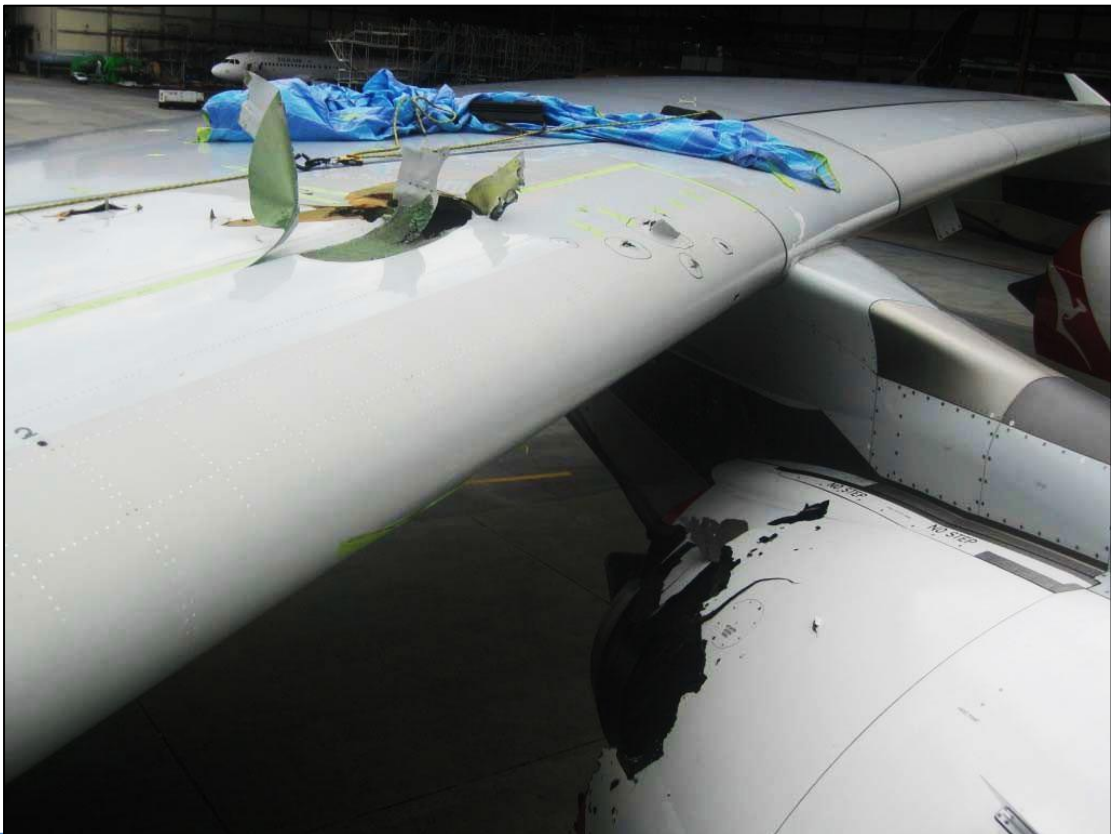
Figure 5: Forward view of engine and subsequent damage for this item.

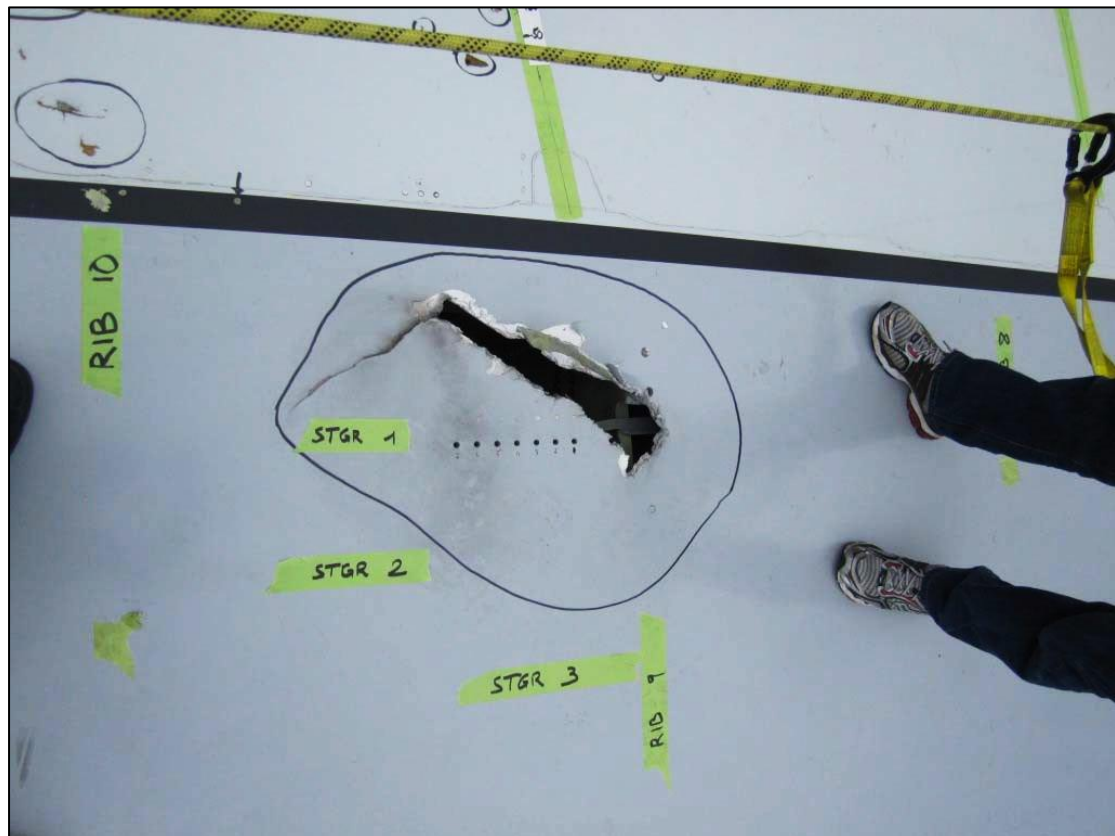
A clearly defined perforation of the top skin resulting in the displacement of some (7) topskin fasteners in the same area and located between the front spar and stringer No. 2 at Rib 9-10. A large chordwise crack is also emanating from the forward portion of the damage.

Figure 6: Location of damage WU-2

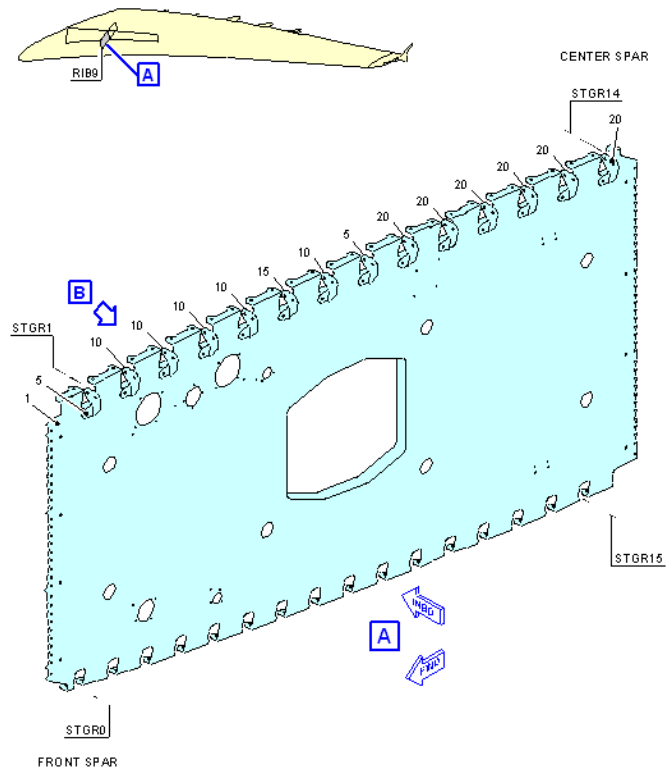
Internally, The Front spar has been penetrated and is damaged extensively, slightly outboard of Rib 9 while Rib 9 itself has suffered damage to the forward section has been penetrated close to the top skin.

Figure 7: Rib 9 section damaged

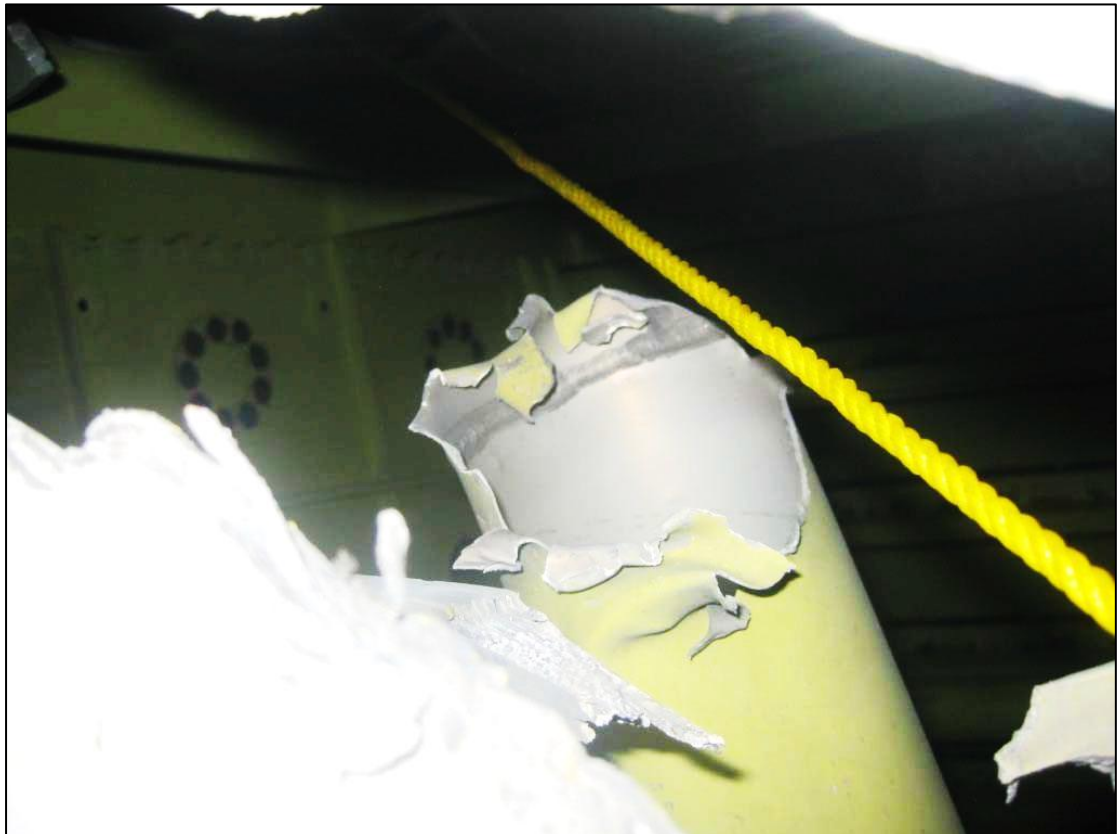
Figure 8: Severed fuel pipe at frontspar/Rib 9

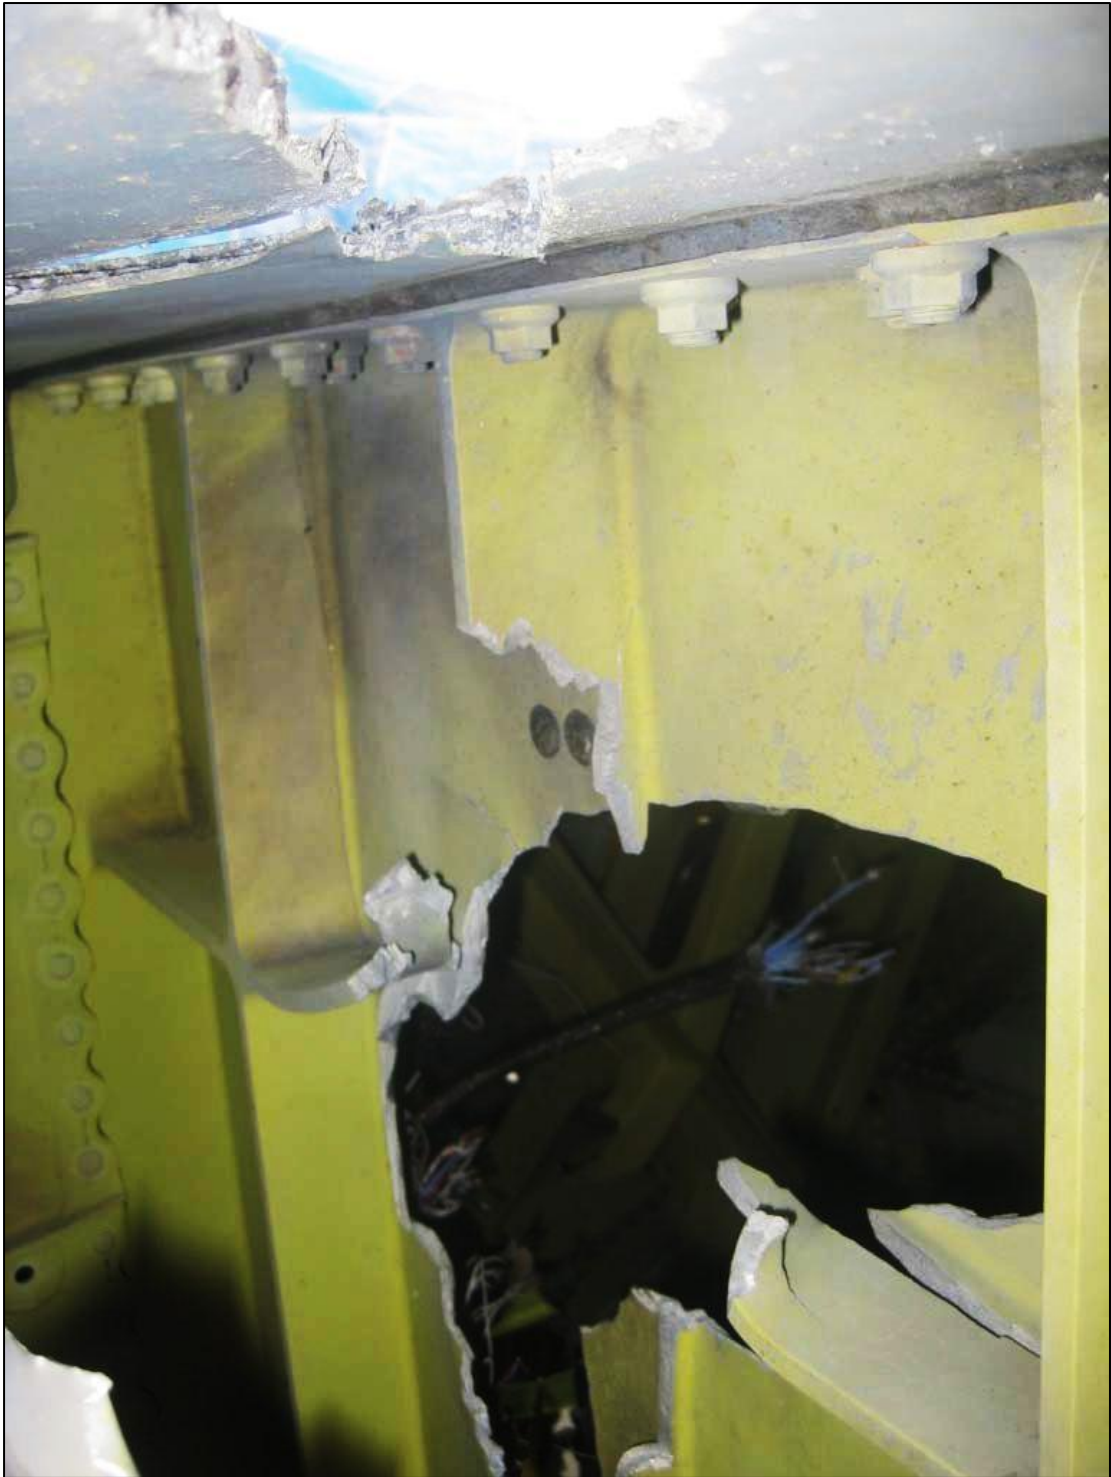
Figure 9: Section of front spar damaged view in aft direction)

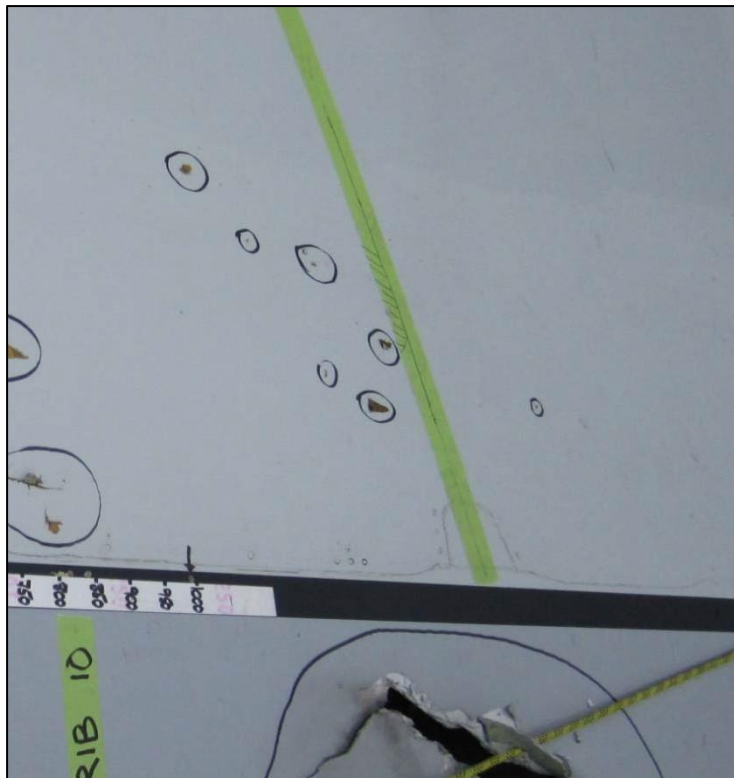
All damages appear superficial on the outer surface of these panels with no penetration of the honeycomb. There is also a slight bulge of the panel at the inboard edge.

Figure 10: Close up view of seven damage locations

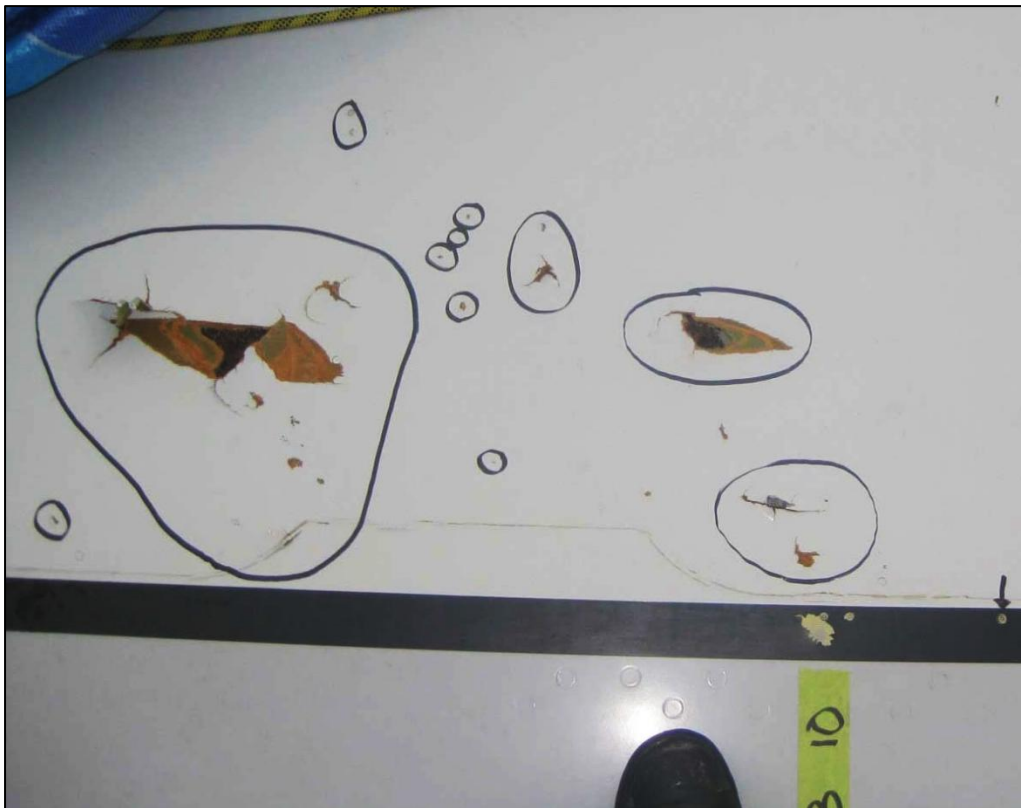
**Sevral damages to the surface of outboard top panel. 3 of the 12 damages show perforation of the panel with one damage still having part of the internal metallic structure lodged in the perforation.**

Figure 11: Overview showing all 12 damages

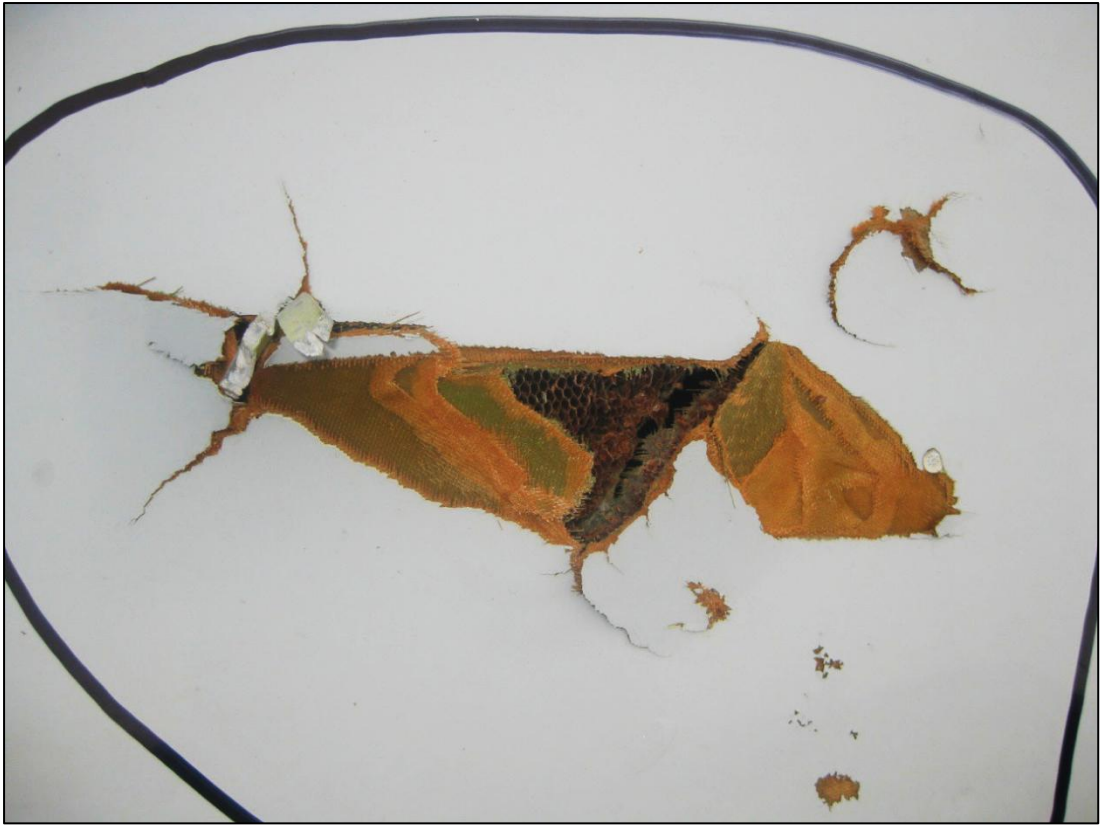
Figure 12: Largest of the 3 skin perforations with metal still lodged in structure

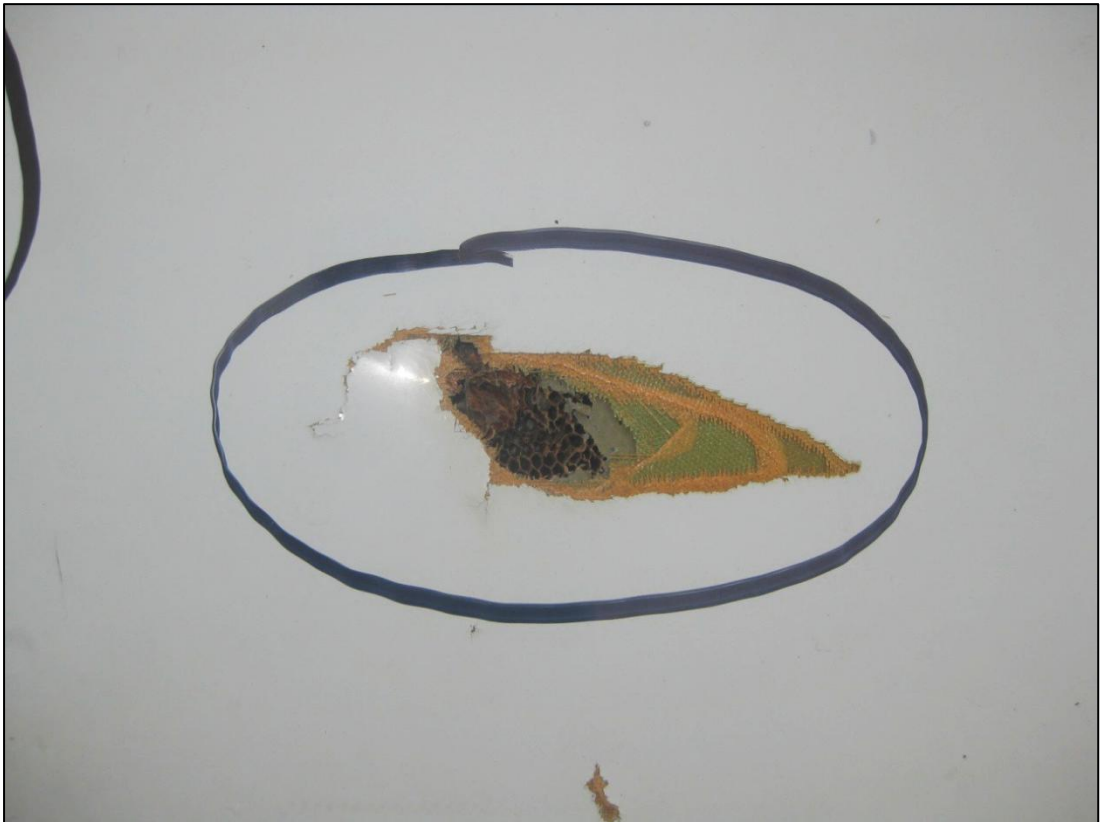
Figure 13: Skin perforation showing honeycomb

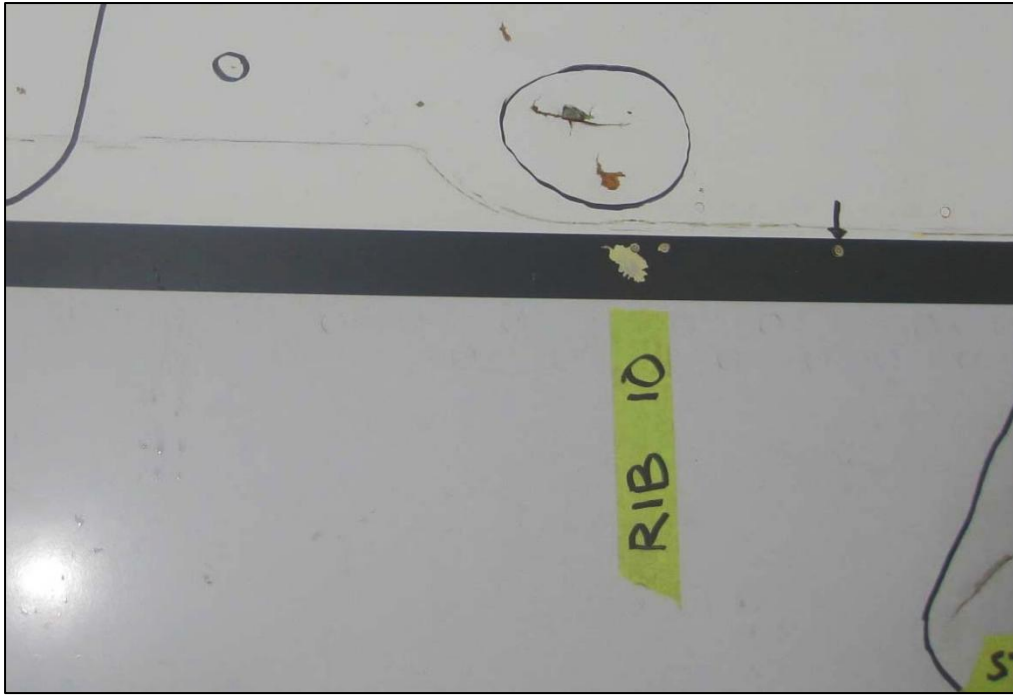
Figure 14: Perforation with metal lodged in structure
